**SITUATION REPORT  
INCIDENT COMMAND POST GOLD KING  
GOLD KING MINE RELEASE INCIDENT  
U.S. ENVIRONMENTAL PROTECTION AGENCY**

**Subject:** EXECSUM / SITREP #48  
Gold King Mine Release Incident  
San Juan County, Colorado  
Latitude: 37.8945 Longitude: -107.6384

**Date:** 03 November 2015

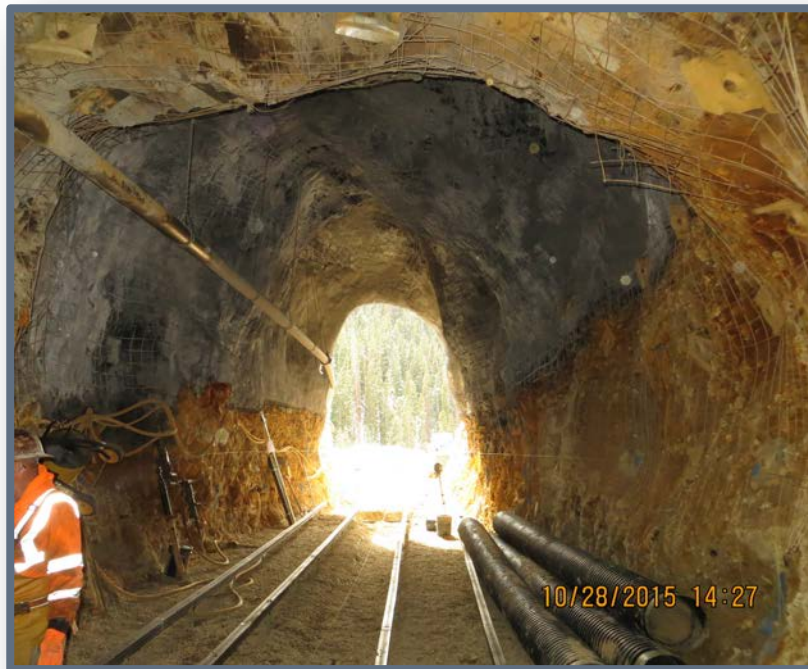
Stabilization activities inside Gold King Mine adit (28 October 2015).

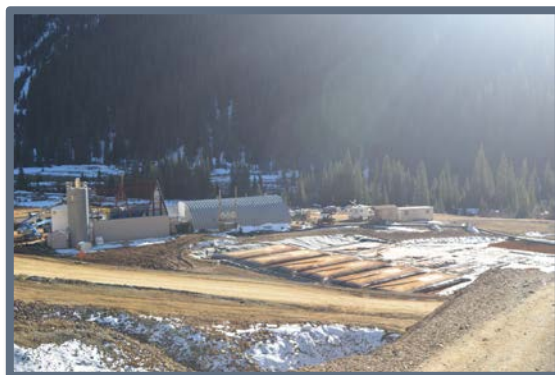
- A pipeline is conveying water from Gold King Mine to the Gladstone ponds en route to the water treatment system.
- Treatment system is operational (including the tiered solid dewatering pad) and is treating between 550 to 600 gallons per minute (gpm).

Gladstone treatment system in operation.
